**CITY OF FOREST GROVE INVENTORY OF HISTORIC PROPERTIES
HISTORIC RESOURCE SURVEY FORM
WASHINGTON COUNTY, OREGON**

Historic Name: _____ **Date of Construction:** c. 1910
Common Name: _____ **Original Use:** Church
Address: 1719 Cedar Street **Present Use:** Church
City: Forest Grove **Architect:** _____
Zoning: A1 **Builder:** _____
T/R/S: T. 1S., R. 3 W. Sec. 6 **Theme:** Culture: Religion
Map No.: 1 S 3 6BD **Tax Lot:** 800 **Style:** Craftsman
Addition: Original Town Plat
Block: 31 **Lot:** 4 **Quad:** USGS Forest Grove 7.5' **Building** **Structure** **Site**

Recorded By: Peter J. Edwards, *Columbia Historical Research*
Date: August 1993

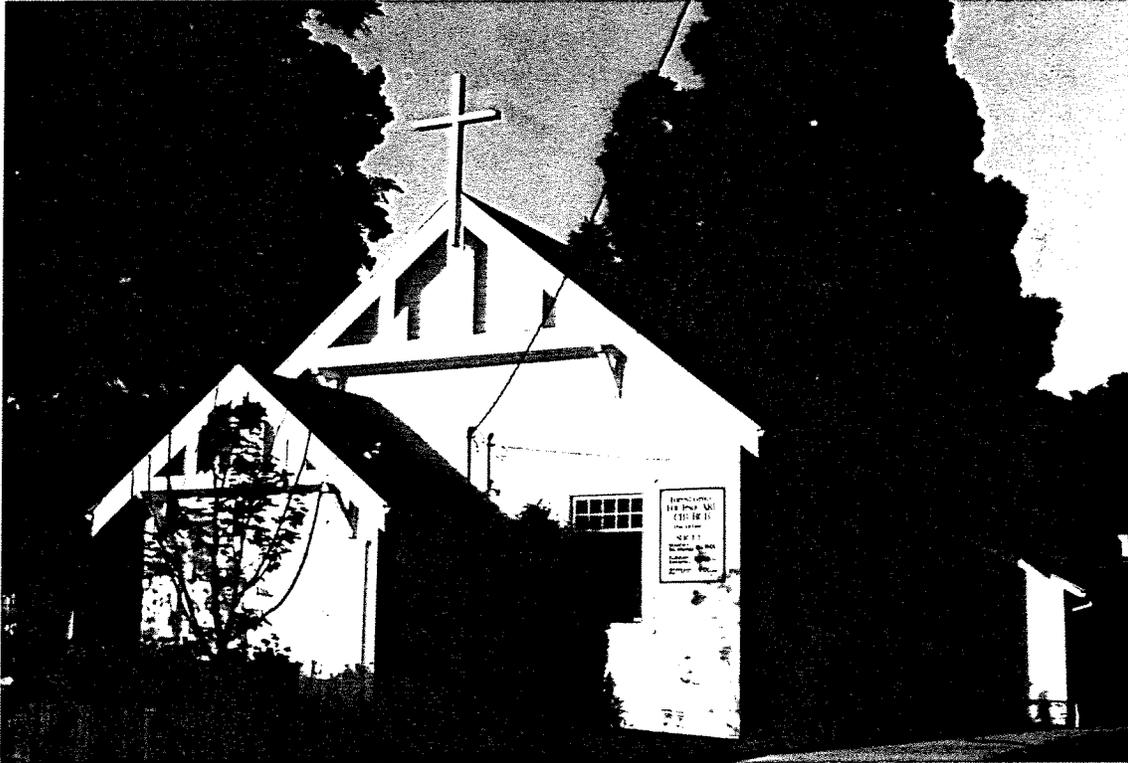
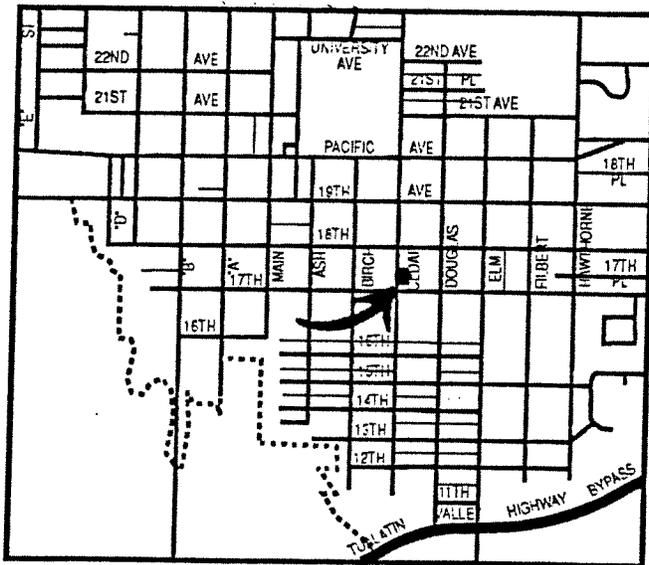
Name :
Address: 1719 Cedar Street
Resource #:

Plan Type/Shape: Rectangular **Number of Stories:** 1
Foundation Material: Concrete and Brick **Basement (Y/N):** N
Roof Form and Materials: Gable with composition shingles
Wall Construction: Wood **Structural Frame:** Stud
Primary Window Type: 1/1 DHS, 10/1 bungalow, some with aluminum storm windows
Exterior Surfacing Materials: Shiplap with cornerboards and watertable
Decorative Features: Purlins and braces; bargeboards; exposed rafters; stickwork
Other : Enclosed gable roof porch on W elevation; 5 panel double doors
Condition: Good Fair Poor Moved _____ (Date):
Integrity: Virtually Intact Minor Alterations Major Alterations

Exterior Alterations/Additions (Dated): Gable and shed roof additions to rear elevation; doors replaced; attached to modular structures to the rear

This building has been added to in the rear, but the basic form of the original building has been retained.

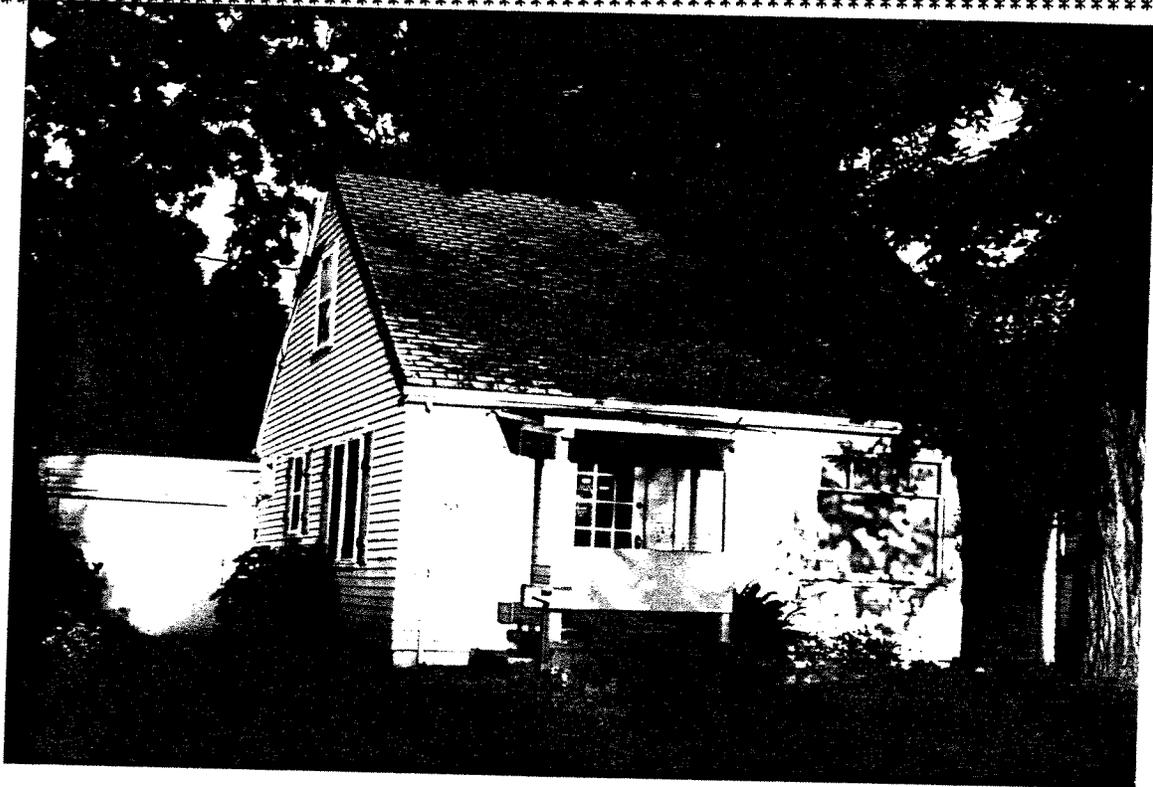
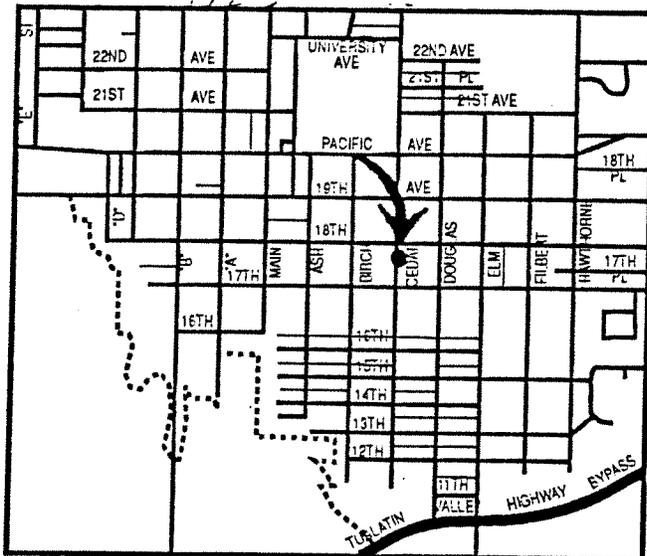
Name :
Address: 1723 Cedar Street
Resource #:

Plan Type/Shape: Rectangular **Number of Stories:** 1.5
Foundation Material: Concrete **Basement (Y/N):** N
Roof Form and Materials: Gable with composition shingles
Wall Construction: Wood **Structural Frame:** Stud
Primary Window Type: 1/1 DHS, 4/1 bungalow
Exterior Surfacing Materials: Clapboard
Decorative Features: Applied decorative shutters
Other : Shed roof porch on W elevation; 15 pane entry door
Condition: Good Fair Poor Moved _____ (Date):
Integrity: Virtually Intact Minor Alterations Major Alterations

Exterior Alterations/Additions (Dated): Shed porch is a replacement

This simple house was built during the transition from the Craftsman style to smaller picturesque styles like Cape Cod Colonial. The house has a bungalow window, but none of the other Craftsman decorative elements.

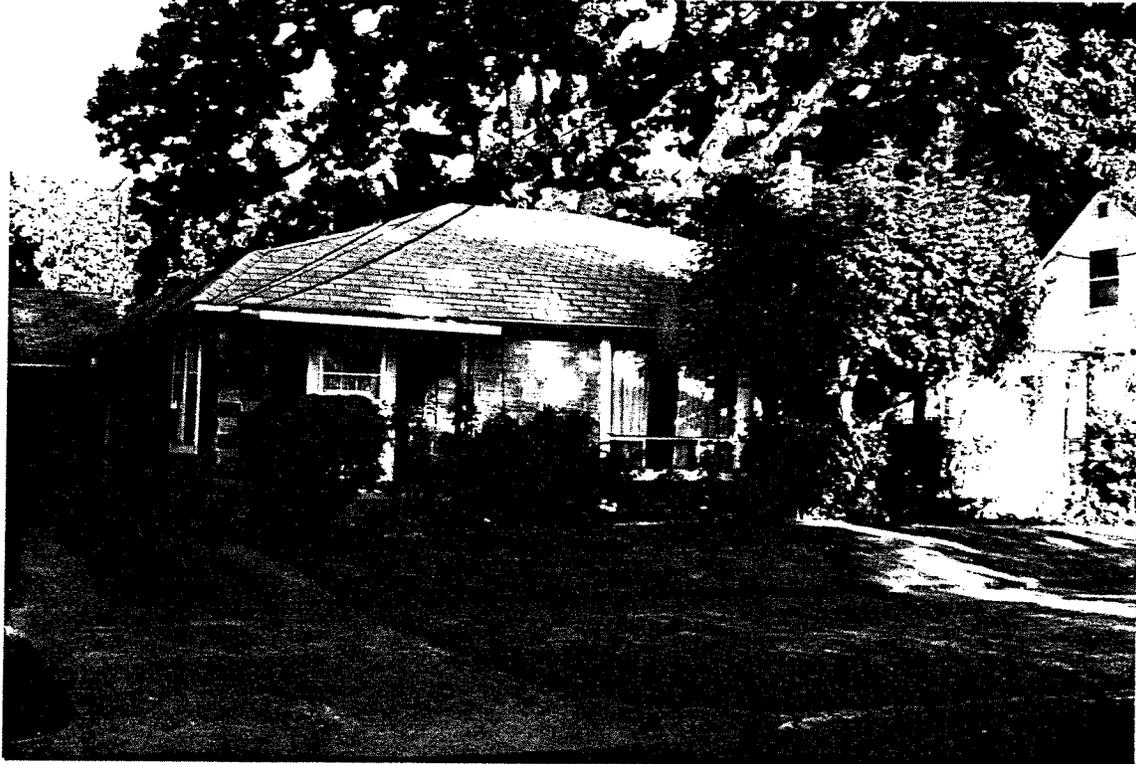
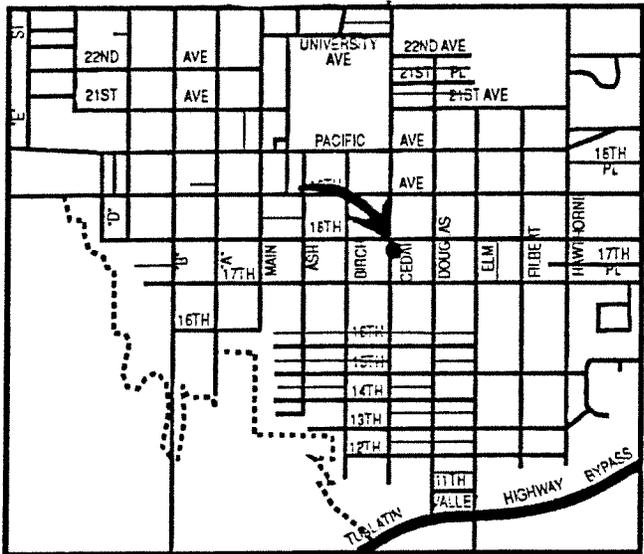
Name :
Address: 1729 Cedar Street
Resource #:

Plan Type/Shape: Rectangular	Number of Stories: 1
Foundation Material: Concrete	Basement (Y/N): N
Roof Form and Materials: Hip with composition shingles	
Wall Construction: Stone	Structural Frame: Masonry
Primary Window Type: 1/1 DHS with aluminum storm windows, 4 pane casement	
Exterior Surfacing Materials: Cast stone	
Decorative Features: None	
Other : Shed roof porch on W elevation [not original]	
Condition: Good <input checked="" type="checkbox"/> Fair <input type="checkbox"/> Poor <input type="checkbox"/> Moved _____ (Date):	
Integrity: Virtually Intact <input type="checkbox"/> Minor Alterations <input checked="" type="checkbox"/> Major Alterations <input type="checkbox"/>

Exterior Alterations/Additions (Dated): Porch replacement; storm windows added

This unique house takes a bit of influence from the early 20th century work of Frank Lloyd Wright. The Prairie style, heavily influenced by Wright, featured low pitched roofs, casement windows groups in continuous bands, and rectangular ground hugging composition. These features are all found in this vernacular adaptation of the Prairie style.

The cast stone of this house substitutes for brick or stucco preferred by the Prairie style, but the other elements are clear. The house has a definite ground hugging feel and the roof is so low pitched and an attic is probably impractical.

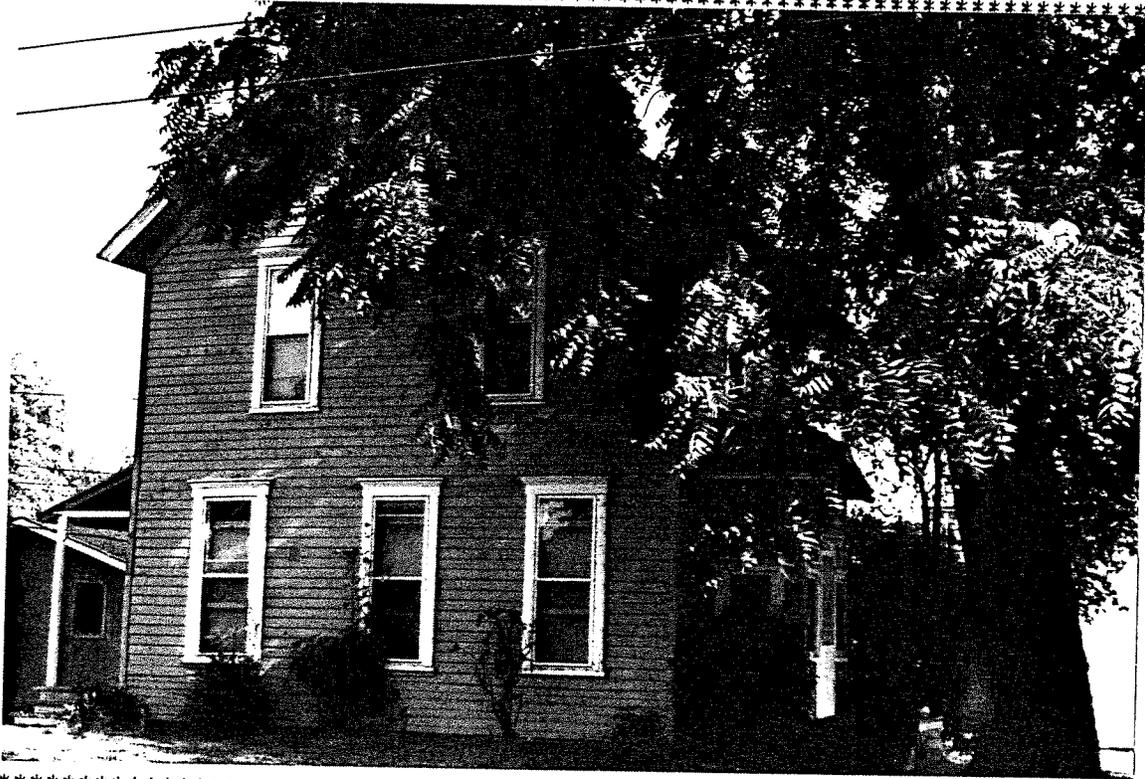
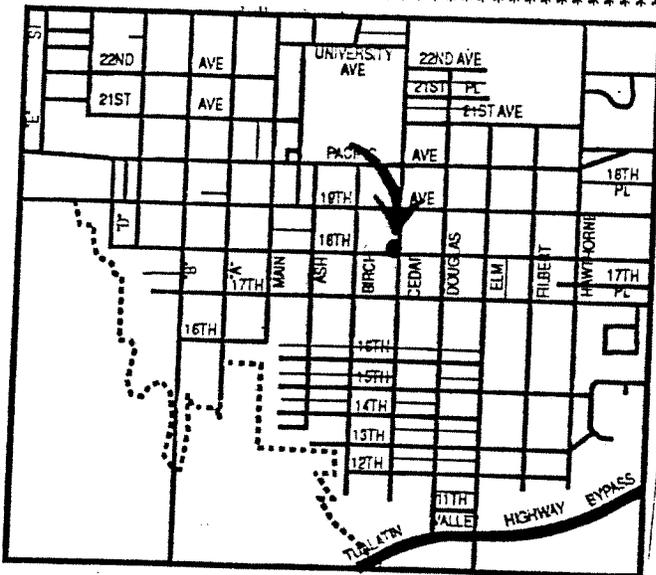
Name : Geiger House
Address: 1804 Cedar Street
Resource #:

Exterior Surfacing Materials: Shiplap with cornerboards and watertable

Decorative Features: Frieze, brackets on rear shed porch, corbeled chimney cap

Other : Gable lean to off rear elevation, enclosed mansard roof porch on S elevation, shed porch on S elevation — attached to gable lean to

Exterior Alterations/Additions (Dated): Rear gable roof lean to added c. 1875; S elevation mansard porch added c. 1875

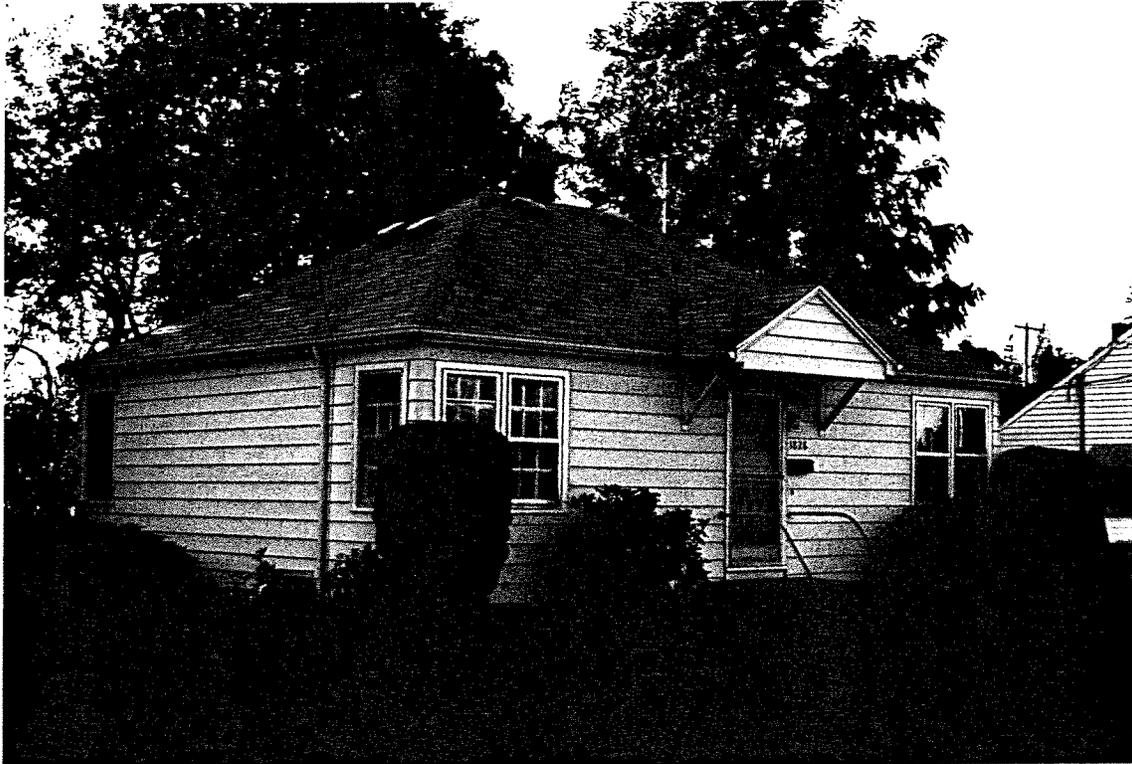
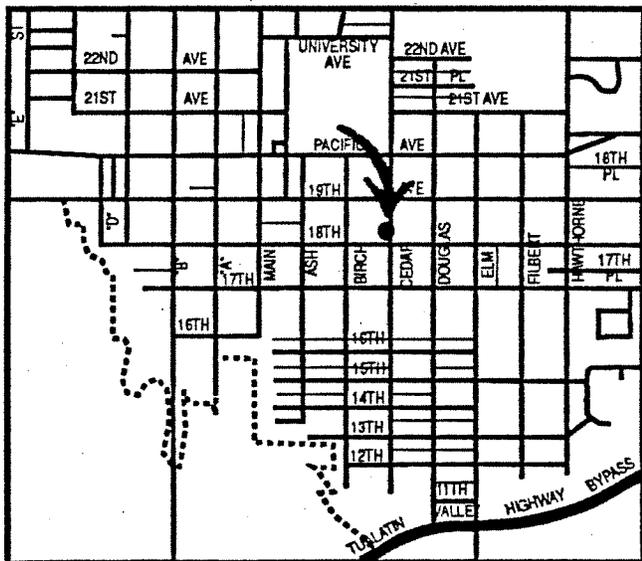
Name :
Address: 1828 Cedar Street
Resource #:

Plan Type/Shape: Rectangular **Number of Stories:** 1
Foundation Material: Concrete **Basement (Y/N):** Unk
Roof Form and Materials: Hip with composition shingles
Wall Construction: Wood **Structural Frame:** Stud.
Primary Window Type: 6/6 DHS with aluminum storm windows
Exterior Surfacing Materials: Wide dropped siding
Decorative Features: None
Other : Gable roof porch on E elevation with purlins and braces; 1 panel, 1 lite entry door
Condition: Good Fair Poor Moved _____ (Date):
Integrity: Virtually Intact Minor Alterations Major Alterations

1828 Cedar is a good example of the simple unadorned houses built between 1935 and 1950. It has not been altered appreciably since being constructed in 1943.

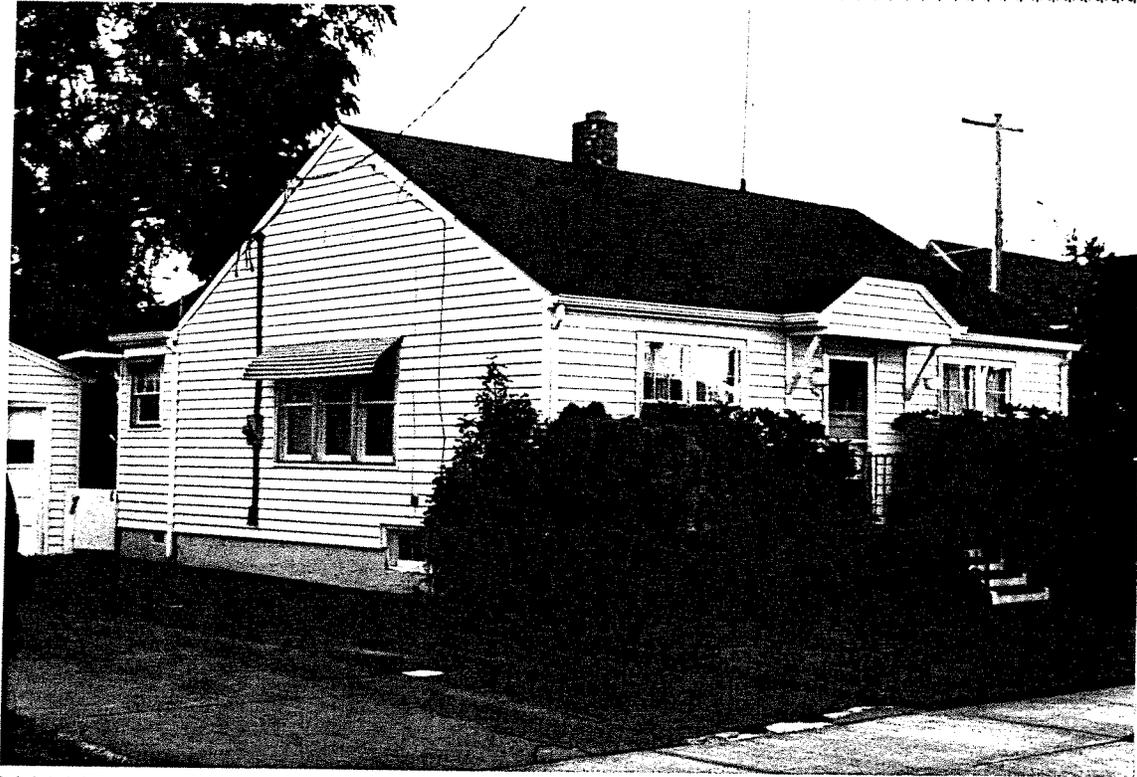
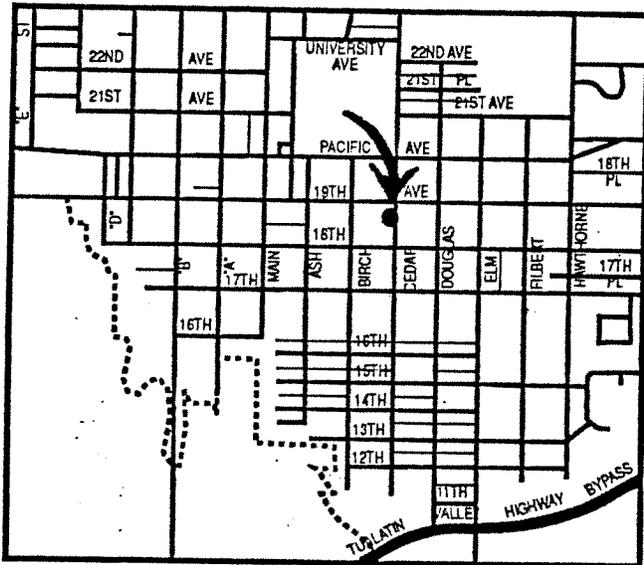
Name :
Address: 1838 Cedar Street
Resource #:

Plan Type/Shape: Rectangular **Number of Stories:** 1
Foundation Material: Concrete **Basement (Y/N):** N
Roof Form and Materials: Gable with composition shingles
Wall Construction: Wood **Structural Frame:** Stud.
Primary Window Type: 6/1 DHS with aluminum storm windows
Exterior Surfacing Materials: clapboard with cornerboards
Decorative Features: None
Other : Hip on gable roof porch on E elevation; 3 panel 3 light entry door; gable roof Ell on W elevation.
Condition: Good Fair Poor Moved _____ (Date):
Integrity: Virtually Intact Minor Alterations Major Alterations

Exterior Alterations/Additions (Dated): Gable Ell added to rear of house (nd); breezeway built between house and garage.

This house, like its neighbor to the south, was built in 1943 and demonstrates the limited financial means of those times. It lacks ornament and is simple and small. It has been altered to include a gable addition to the rear and an attachment to a garage to the SW.

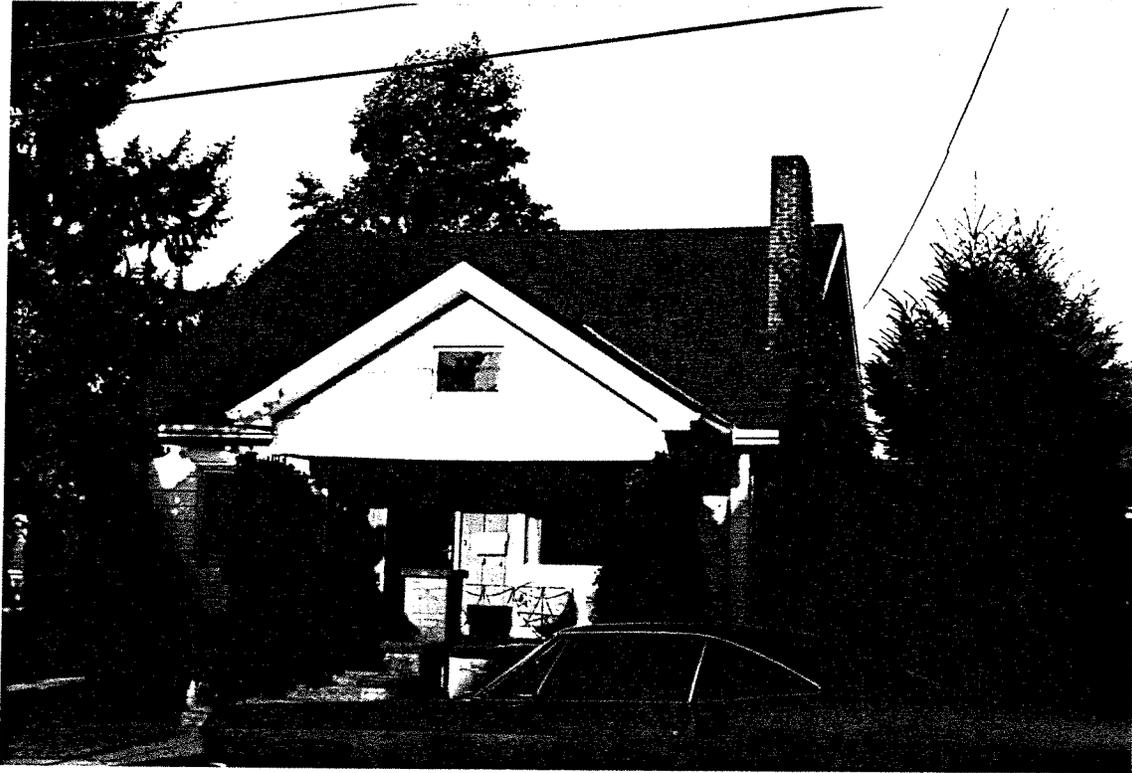
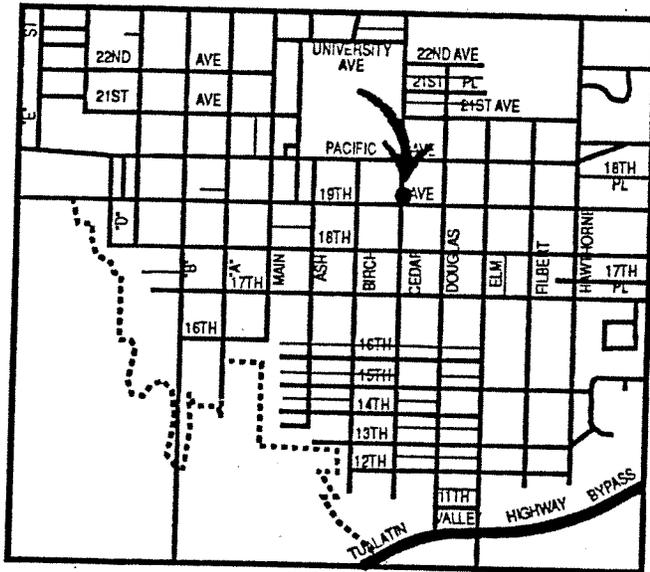
Name :
Address: 1909 Cedar Street
Resource #:

Plan Type/Shape: Rectangular **Number of Stories:** 1.5
Foundation Material: Concrete **Basement (Y/N):** Y
Roof Form and Materials: Gable, with composition shingles
Wall Construction: Wood **Structural Frame:** Stud.
Primary Window Type: 1/1 DHS with aluminum storm windows; 1 pane fixed aluminum windows.
Exterior Surfacing Materials: Non-original wide dropped siding
Decorative Features: Exposed rafters
Other : Gable roof porch W elevation; partially enclosed shed roof porch on N elevation; rectangular and polygonal window bays on N elevation; exterior end wall chimney, W elevation.
Condition: Good Fair Poor Moved _____ (Date):
Integrity: Virtually Intact Minor Alterations Major Alterations

Exterior Alterations/Additions (Dated): Siding replaced, c. 1950; battered porch posts removed, replaced with metal, c.1950. Brick piers remain. Bargeboards also removed.

1909 Cedar suffers from major alterations dating to the 1950's which removed the bungalow style battered porch posts, although the brick piers are still visible. The alterations also included the replacement of the siding and the removal of the bargeboards.

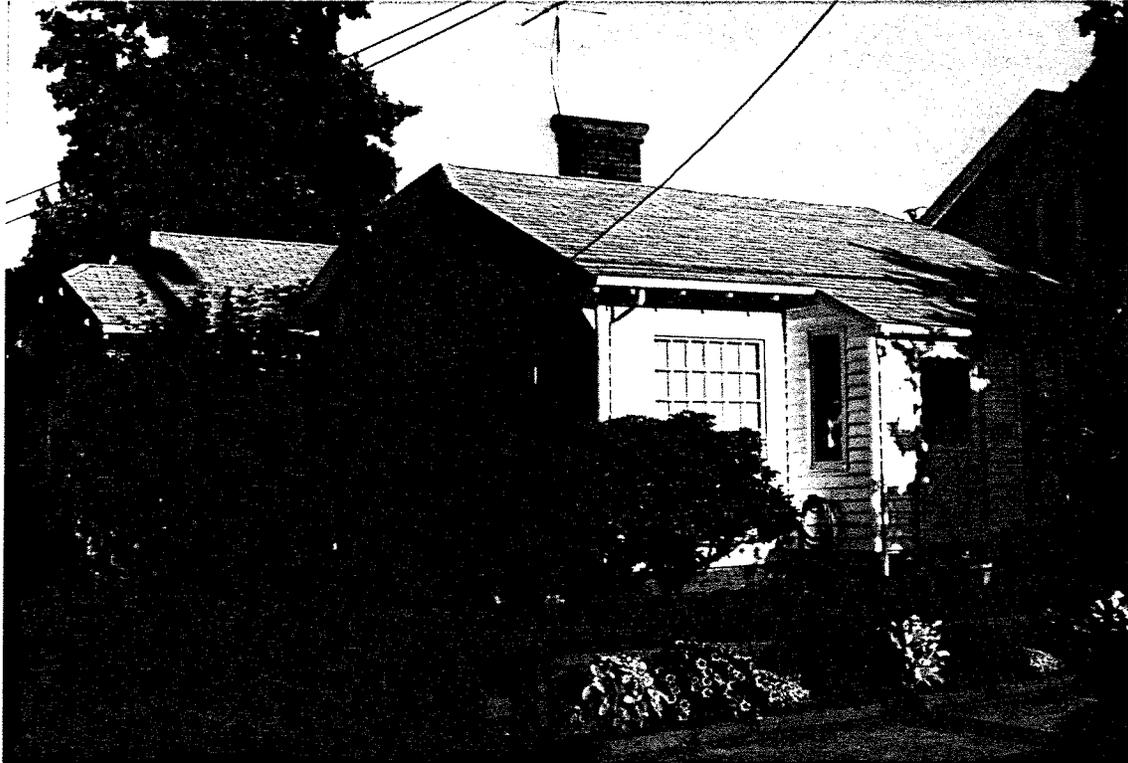
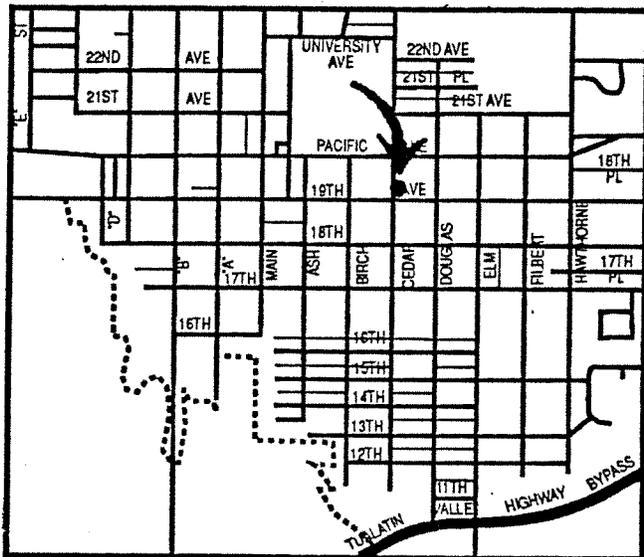
Name :
Address: 1913 Cedar Street
Resource #:

Plan Type/Shape: Rectangular **Number of Stories:** 1
Foundation Material: Concrete **Basement (Y/N):** N
Roof Form and Materials: Hip on Gable, composition shingles
Wall Construction: Wood **Structural Frame:** Stud.
Primary Window Type: 6/1 DHS with aluminum storm windows; 6 pane casement; 24 pane fixed.
Exterior Surfacing Materials: Wide dropped siding with cornerboards.
Decorative Features: Purlins and braces, exposed rafters.
Other : Enclosed shed roof porch on W elevation
Condition: Good Fair Poor Moved ____ (Date):
Integrity: Virtually Intact Minor Alterations Major Alterations

Exterior Alterations/Additions (Dated): Large hip on gable rear addition. The addition is similar in size and scale to the original house and was probably added soon after the original house was built.

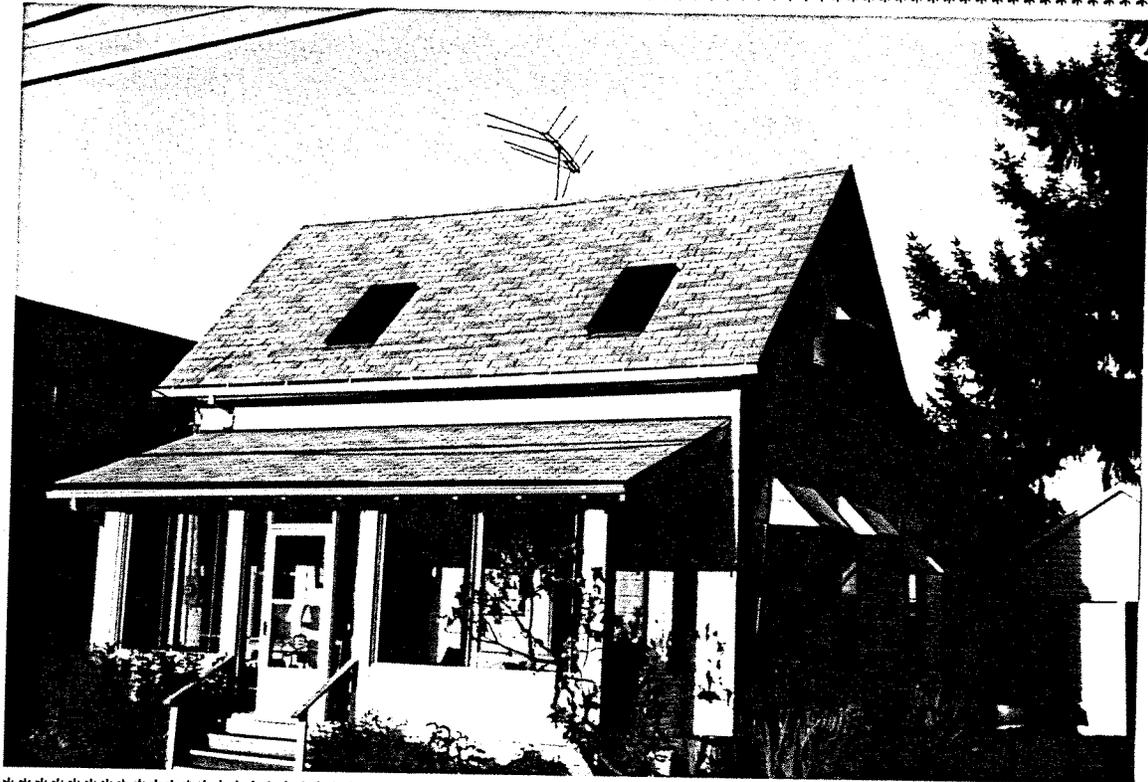
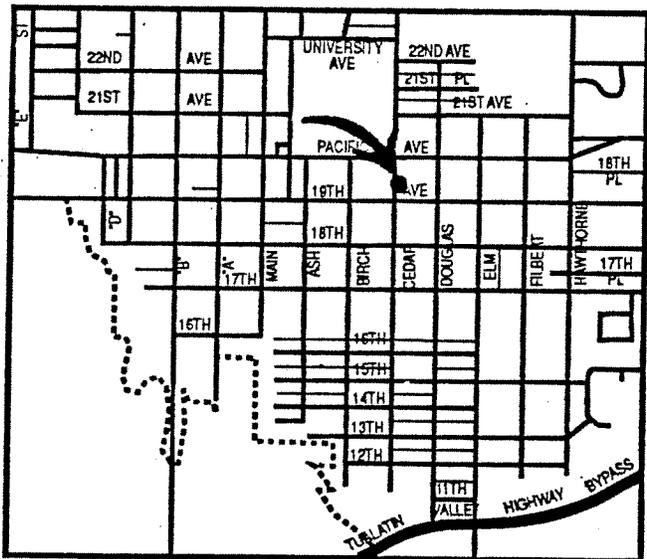
Name :
Address: 1919 Cedar
Resource #:

Plan Type/Shape: Rectangular **Number of Stories:** 1.5
Foundation Material: Wood posts on concrete piers **Basement (Y/N):** N
Roof Form and Materials: Gable, composition shingles
Wall Construction: Wood **Structural Frame:** Stud.
Primary Window Type: 1/1 DHS with plain surrounds and aluminum storm windows; some sliding aluminum
Exterior Surfacing Materials: Wide dropped with cornerboards and watertable
Decorative Features: Frieze
Other : Full width enclosed shed roof porch, W elevation; gable roof Ell, E elevation
Condition: Good Fair Poor Moved ____ (Date):
Integrity: Virtually Intact Minor Alterations Major Alterations

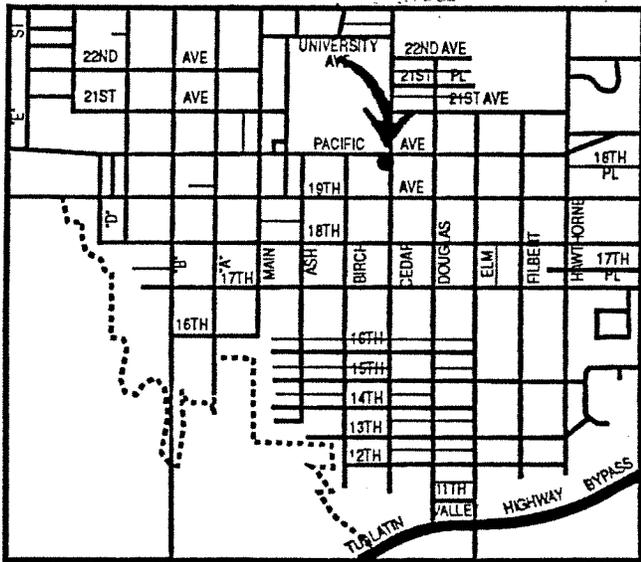
Name :
Address: 1928 Cedar Street
Resource #:

Plan Type/Shape: Rectangular **Number of Stories:** 2
Foundation Material: Brick piers **Basement (Y/N):** N
Roof Form and Materials: Cross - Gable with composition shingles
Wall Construction: Wood **Structural Frame:** Stud.
Primary Window Type: Narrow 1/1 DHS with gabled lintels
Exterior Surfacing Materials: Shiplap, with cornerboards and watertable
Decorative Features: Frieze
Other : Full width shed roof porch on E elevation; 1 panel, glazed door; Hip roof Ell on W elevation, attached to shed roof Ell on W elevation
Condition: Good Fair Poor Moved ____ (Date):
Integrity: Virtually Intact Minor Alterations Major Alterations
